Chapter 3

THE ACCOUNT OF WORLD TRADE CENTER 2

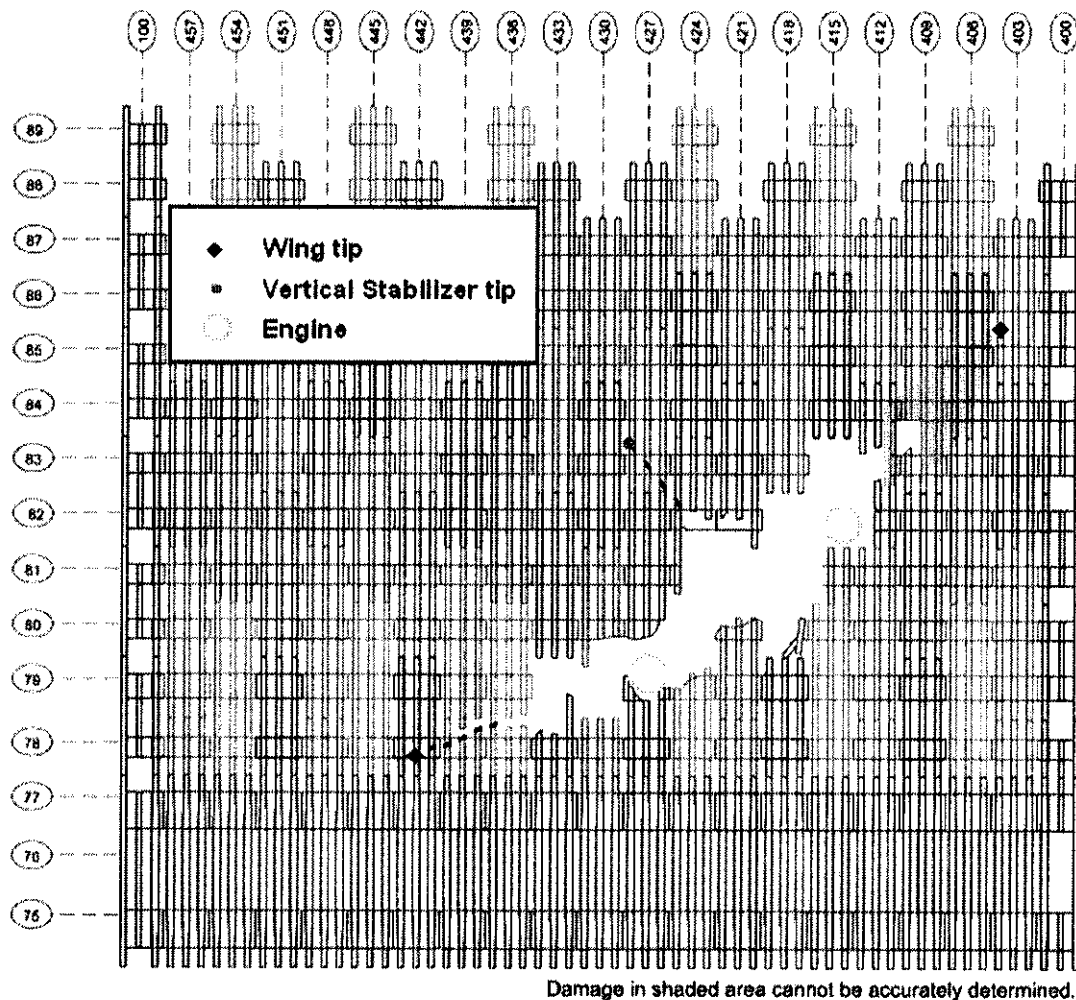
Figure 3-2. South face damage of WTC 2 with key aircraft component locations marked.

bank angle was steeper than that of AA Flight 11, this entry wound stretched over nine floors, from 77 to 85, rather than eight in WTC 1 (Figure 3-2). The occupancy of those floors is shown in Table 3-1.

The bulk of the impact damage was confined to six floors. Figure 3-3 shows the combined damage. Floors 77, 84, and 85 were struck only by the outer extent of the wings. Empty of fuel, the light framing

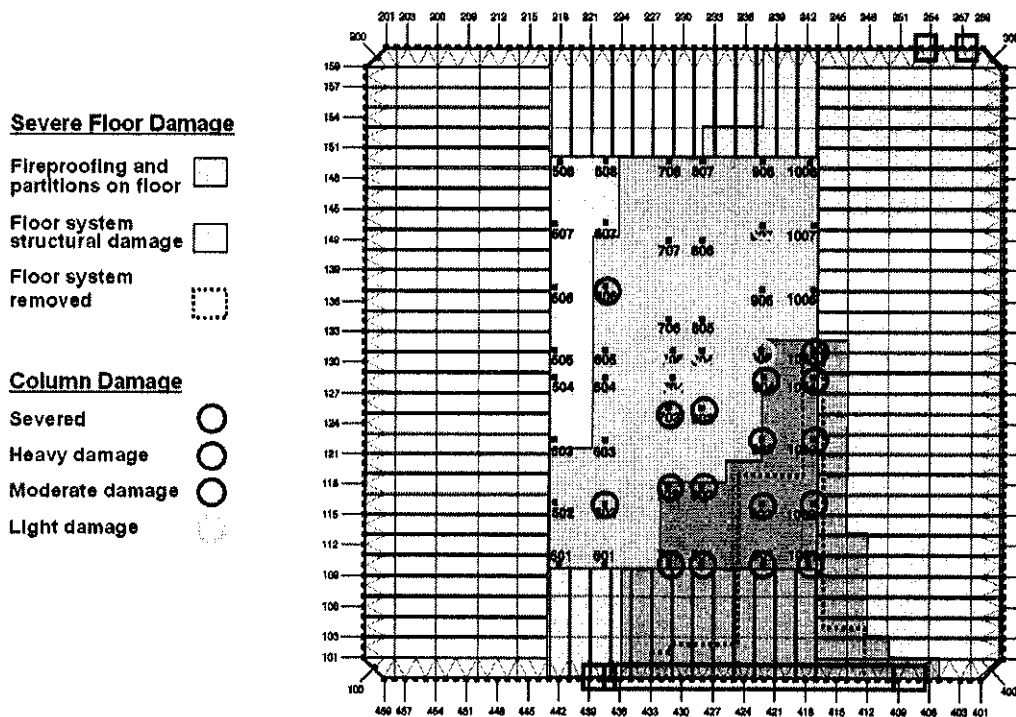
Figure 3-3. Simulation of aircraft impact damage to the 78th through 83rd floors in WTC 2.

The middle of the left wing hit the 78th floor, severing nine perimeter columns and breaking 19 windows on the south face. The SFRM was stripped from the floor trusses over the same width as the building core. The stripping of insulation from the trusses continued inward across the tenant space and about two thirds of the way into the core. There was no direct core column damage from the debris on this floor. However, the southeast corner core column was so damaged on the 80th floor that it broke at its splices on the 77th and 83rd floors.

There was heavier damage to the 79th floor. The left engine and the inboard section of the left wing shattered a 25 ft wide section of the center of the floor slab all the way to the core of the building and severed 15 perimeter columns. Reaching the building core, the debris severed nine columns, heavily damaged another, and abraded the SFRM from the eastern two thirds of the columns and trusses all the way to the north end of the core.

The damage was most severe on the 80th and 81st floors, hit directly by the fuselage. On the lower floor, a chunk of the floor slab was broken, just above the affected piece of the 79th floor. In addition, a 70 ft deep strip along the east side of the core floor was crushed. The north side floor slab sagged along its eastern end. Ten of the perimeter columns severed on the 79th floor were displaced here also. Within the building core, ten columns were severed, including many that were severed on the 79th floor. The SFRM was stripped not only from the eastern two thirds of the core structural elements, nearly to the north wall, but also from most of the trusses on the east tenant space, all the way to the north façade.

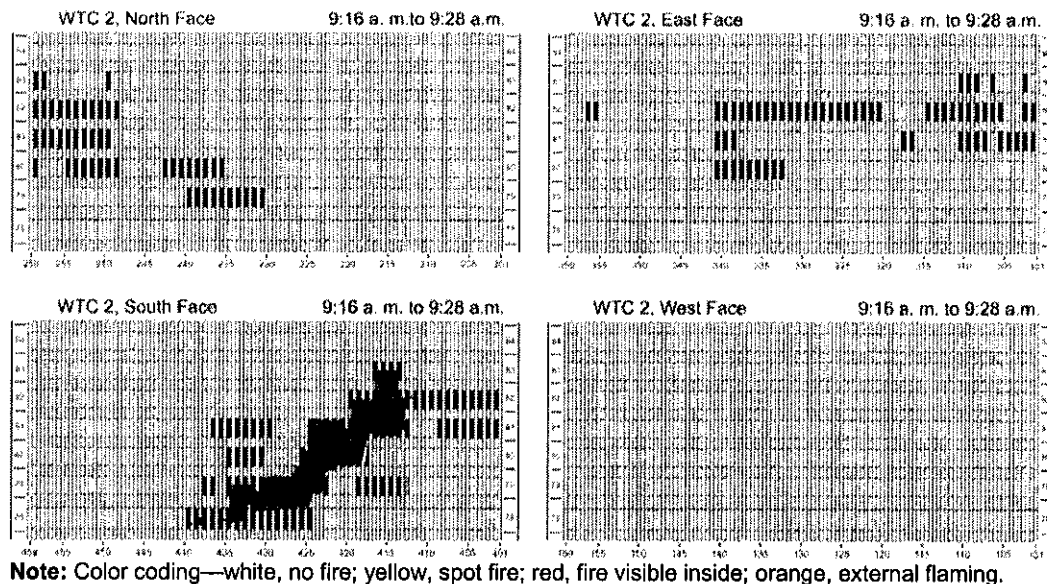
Figure 3-4. Representation of exterior views of the fires on the four faces of WTC 2 at about 9:20 a.m.

For the next half hour, small fires were burning in and near the aircraft impact cavity on the south side of the building. There were vigorous fires on the east side of the 80th through 83rd floors (Figure 3-4), especially on the northeast end of the 81st and 82nd floors, where the aircraft had bulldozed the office desks and chairs and added its own combustibles. In addition to the ample supply of fuel, these fires had access to plenty of air, as numerous windows on the east face had been blown out by the impact or fireball. They would continue to burn as long as the building stood.

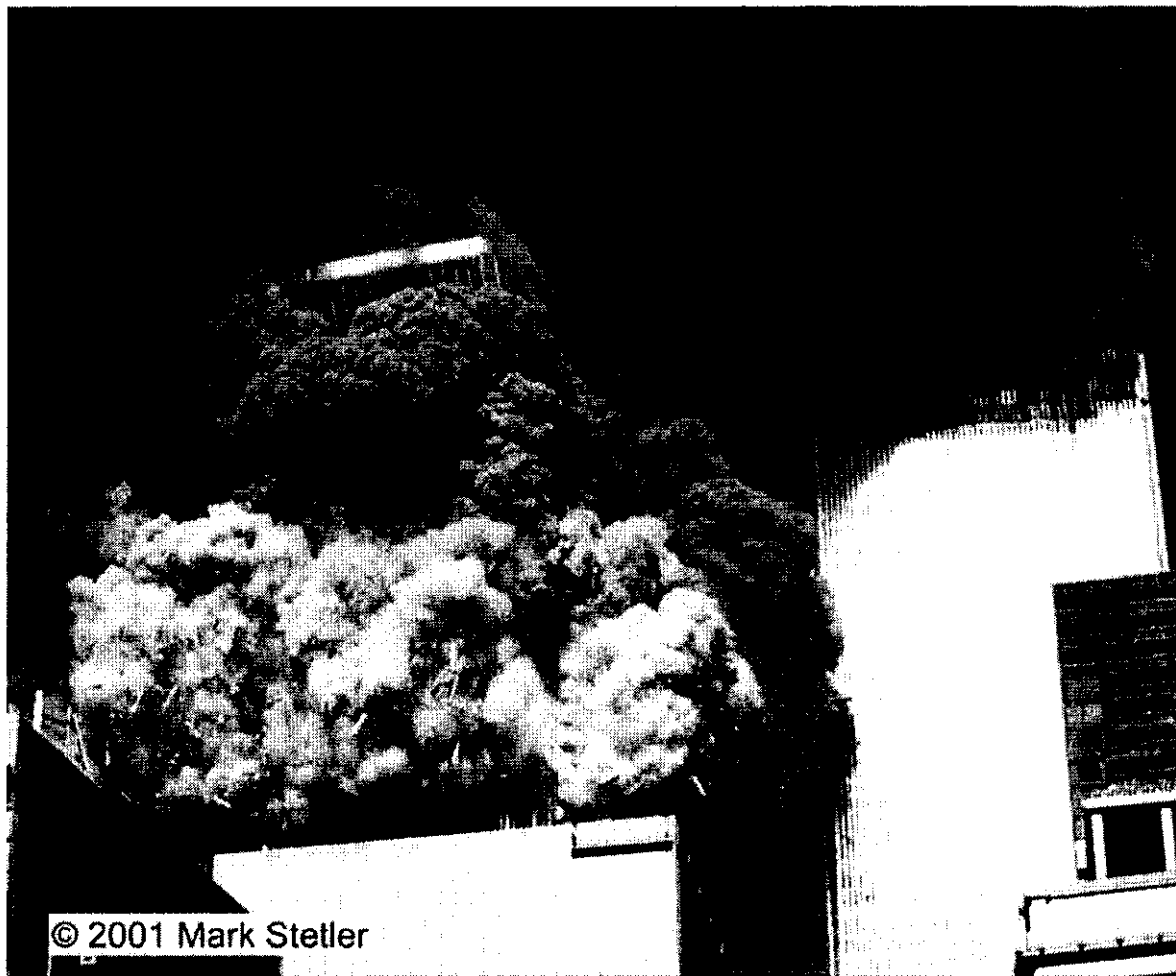
Figure 3–5. Photograph of WTC 2 tilting to the southeast at the onset of collapse.

The physical condition of the tower had deteriorated seriously. The inward bowing of columns on the east wall spread along the east face. The east wall lost its ability to support gravity loads, and, consequently, redistributed the loads to the weakened core through the hat truss and to the adjacent north and south walls through the spandrels. But the loads could not be supported by the weakened structure, and the entire section of the building above the impact zone began tilting as a rigid block to the east and south (Figure 3-5). Column failure continued from the east wall around the corners to the north and south faces. The top of the building continued to tilt to the east and south, as, at 9:58:59 a.m., WTC 2 began to collapse.

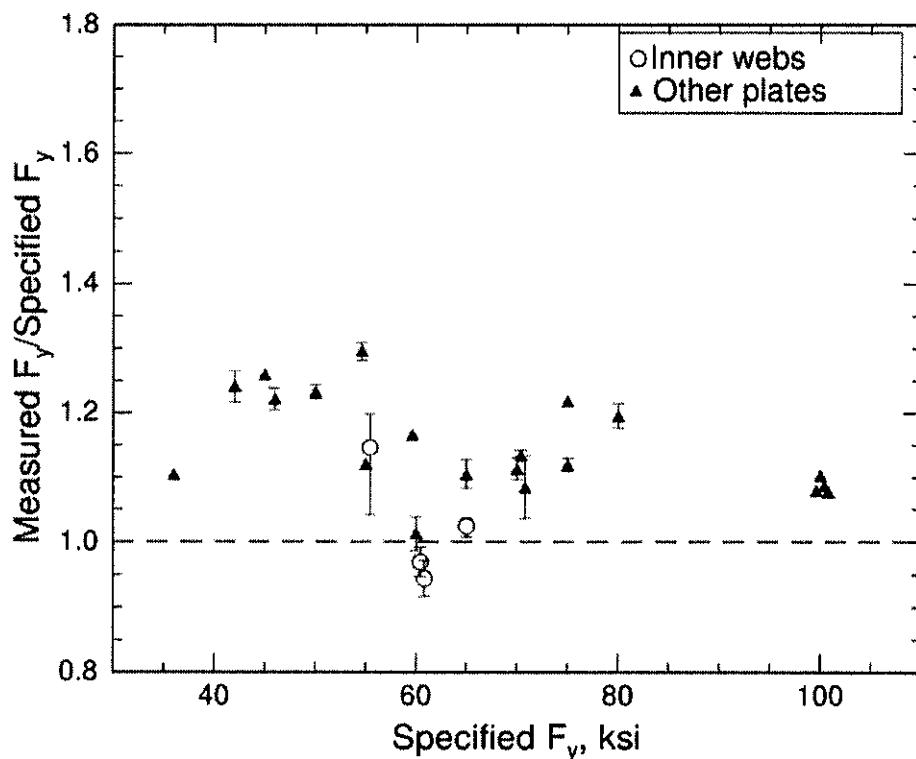
Figure 5-4. Ratio of measured yield strength (F_y) to specified minimum yield strength for steels used in WTC perimeter columns.

- Roughly 13 percent of the measured strength values for the perimeter and core columns were at or below the specified minimums (Figure 5–4). The strength variation was consistent with the historical variability of steel strength and with the effects from damage during the collapse of the towers. The measured values were within the typical design factor of safety.

Note: The ratio values less than 1 arose from natural variation in the steel and did not affect the safety of the towers on September 11, 2001. The bars represent maximum and minimum values from multiple measurements.
